Service Bulletin SB.JS-005

JS1 Tail valve V2 modification & inlet filter installation

Jonker Sailplanes

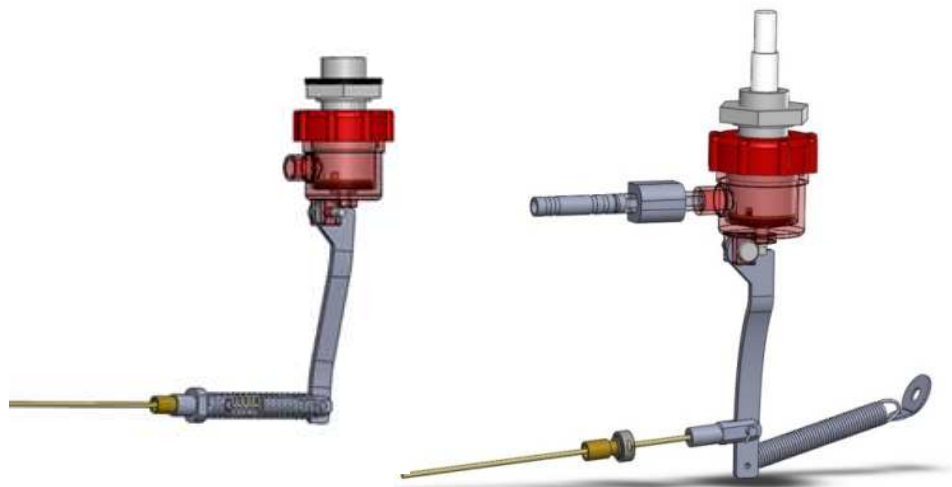
It was reported by a customer that the dumping rate of the tail valve was slower than the dump rate of the main wing tanks. This may lead to the centre of gravity moving outside of the approved aft limit. Investigations showed that:

1. Foreign objects inside the tail tank or objects entering the tail tank during water filling may have obstructed the valve inlet and as a result may restrict the dump rate, and/or prevent proper sealing of the valve.
2. The tail valve may not open fully due to the compression spring not compressing enough and as a result may restrict the dump rate, and/or prevent proper sealing of the valve.

Figure 1: a) Tail valve V2 with compression spring and without the filter; b) Tail valve V2 with the tension spring and filter

1. The procedure to remove and install the tail valve V2, with the following modifications incorporated:
 - a. Inlet filter installed to the valve inlet
 - b. Plunger modified to increase flow rate
 - c. Modified lever to accommodate the tension spring, modified clevis and cable adjuster.
2. The maintenance checks required to ensure correct operation.

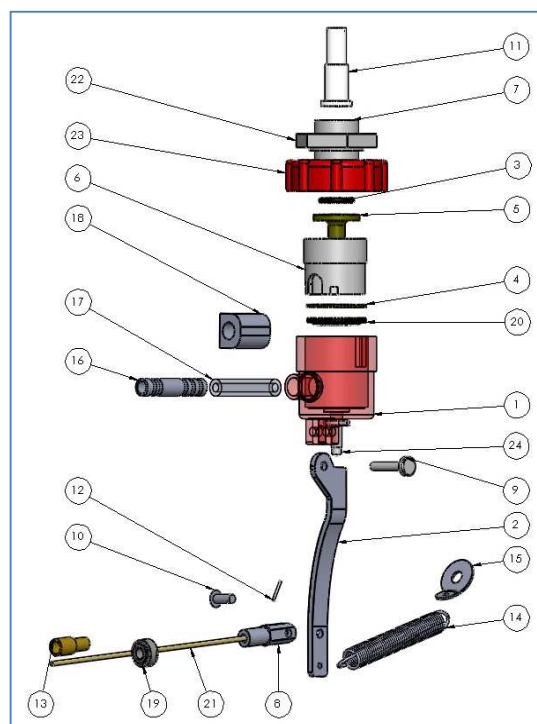
Figure 2: tail valve V2 exploded view

A filter (Fig 2, #11) has been added to the tail valve to prevent debris obstructing the valve plunger. The dump rate of the Tail valve V2 must be tested and if found less than 1 litre per minute, the tail valve must be modified accordingly:

1. The valve inlet must be modified to accommodate the installation of the filter and the internal diameter of the plunger increased. The filter must be cleaned if the dump rate is slower than specified.
2. The compression spring must be removed and replaced with a tension spring (Fig 2, #14) on the opposite side of the cable. The cable adjuster (Fig 2, #13) and clevis (Fig 2, #8) must be removed and replaced to accommodate the tension spring.

1. Remove the tail wheel and mud guard.
2. Undo lever by removing the hinge pin (See Fig 2, #9)
3. Remove the silicon tubing from valve body.
4. Undo the locking nut (See Fig 2, #22)
5. Remove tail valve by rotating the valve anti-clockwise.
6. Remove the valve inlet and replace with the valve inlet with the attached filter.
7. Reinstall the tail valve.
8. Tighten the locking nut by hand.
9. Attached the lever with the hinge pin.
10. Test the dump rate:
 - a. If found according to specifications, reinstall the tail wheel and mud guard.
 - b. If less than specifications the following procedure must commence:

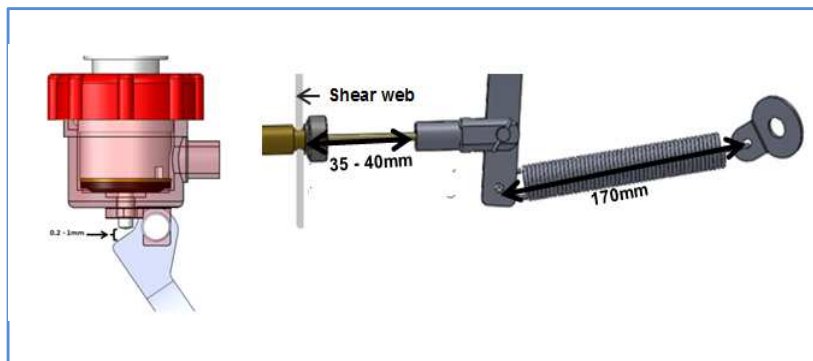
Figure 5: Play specification between valve pin and lever,
lever and spring retainer, clevis and shear web.

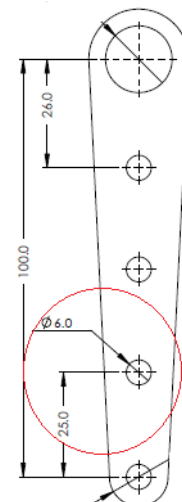
Figure 6: Arm fitted with extra hole.

8. The arm (Fig 3, #4) may have to be fitted with an extra hole, as illustrated in fig 6. in order for the cable to fit. Removal and reinstallation as well as adjustment needs to commence as explained in the maintenance manual issue 2, par 6.6.4. Adjustment of the water ballast system.
9. Install the spring retaining washer (Fig2, #15) on the bottom rudder hinge bolt, at the rear end of the wheel box.
10. Install the lever to the valve body with the hinge pin (Fig2, #9)
11. Attached the cable to the clevis (Fig 3, #9) with the lever and clevis, (Assuring the valve is in the closed position) in the positions as illustrated in figure 6.
12. The tension of the cable can be adjusted with the clevis (Fig3, #9).
13. Install the mud guard and ensure there is no interference with the tail valve and actuators.
14. Install the tail wheel.
15. Test the dump rate and assure it is as specified.
