Service Bulletin SB.JS-002

3 July 2012

Landing Gear Linkage System Adjustment

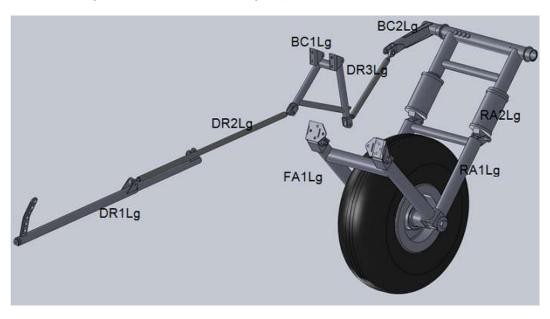
Figure 1 Landing Gear Linkage Elements

A report was filed where the landing gear of a JS1 collapsed during landing on a rough field. Further investigation showed that the probable cause was due to play in the landing gear linkage system when it was locked in the down position.

- 1. Place fuselage on a fuselage cradle and ensure it is safe to retract the main wheel.
- 2. Lock main wheel in down position and ensure the main wheel is off the ground.
- 3. Put hand on rear landing gear arms (RA1Lg and RA2Lg) and feel if there is any play on the hinge in the rear arm. This is the hinge above the shock element that folds during retraction.
- 4. Approximately 3mm of play is normal, but the landing gear lock should hold the wheel rear arms in the locked position. The possible play should be countered by the lock in the cockpit and the play should only be due to the elasticity in the system.

In the case of excessive play, the links must be adjusted according to Procedure 1.
