# Service Bulletin SB.JS-004

22 June 2011

# Replacement of Main Pin Lock System

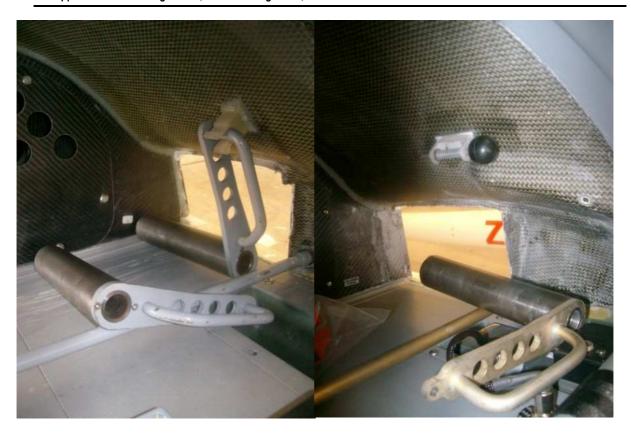
The plastic clips of the main pin lock system harden, become brittle and/or crack due to age, indirect exposure and fatigue.

Figure 1: (left) Plastic clip and main pin v3.4; (right) Main pin v3.5 and lock system 1A-1.06.50

The plastic pin has been replaced by a metal spring-pin locking mechanism.

Since SN010, all aircraft leaving the factory utilise a metal main pin locking mechanism using a sprung pin. This system is referenced by its part number 1A-1.06.50. The main pin has been revised accordingly. Version 3.5 of the main pin differs from prior versions (up to version 3.4) by an extension of its handle. No modifications are required to the wings or to the structure of the fuselage.
