Technical Note TN.JS-005

Landing gear travel adjustment

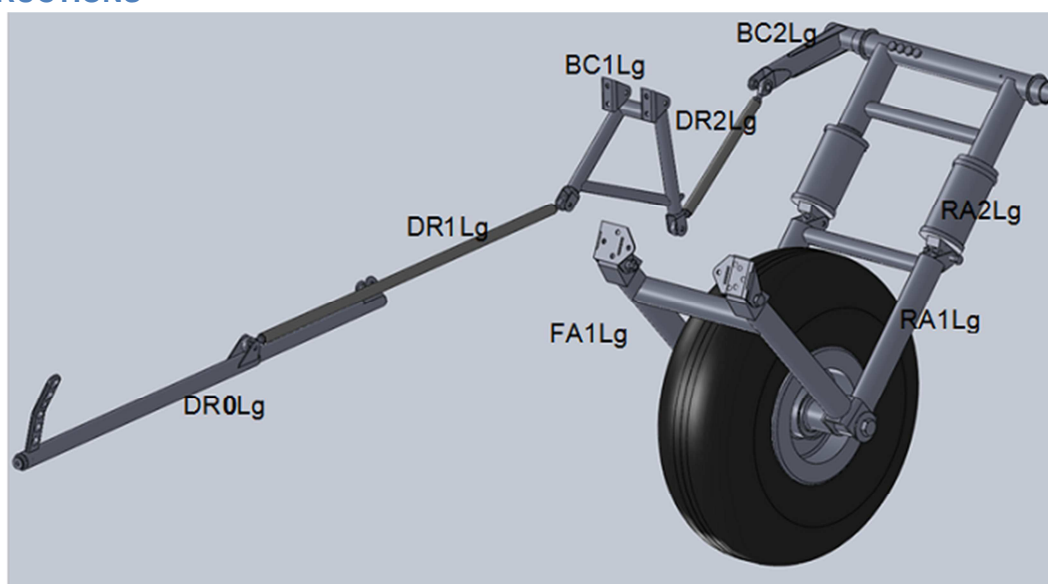
Over time the main wheel tyre may increase in diameter, due to creep from tyre pressure. The increased diameter may result in the wheel touching the landing gear doors, possibly preventing the landing gear doors from closing fully. Installing spacers behind the landing gear brackets will alleviate the problem.

1. Set up the glider so that the fuselage is supported, with the wheel able to retract.
2. Ensure that the wheel is locked in the down position.
3. The four bolts clamping the two bell crank brackets (1A-1.27.60) need to be replaced with M6AB30 SS dome-headed cap screws.

4. Loosen and replace one bolt at a time, keeping the nuts in place with a 10mm spanner. The nuts can be accessed through the oxygen bottle hole, through the access hole in the wheel box, or by removing the right hand side battery box.

5. When all four bolts have been replaced, there will be a gap between the bulkhead and the brackets. Insert the spacers by sliding them in sideways between the bulkhead and the brackets. The spacers must be inserted between the two brackets and slid outwards until seated against the bolts.
