Technical Note TN.JS-019

17 February 2015

Canopy Frame/Canopy Latch Hinge Bolt Interference

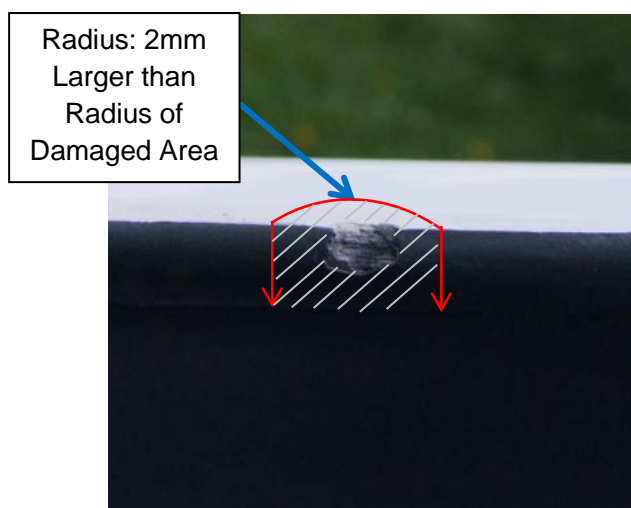
The lack of clearance between Canopy Latch Hinge Bolt (canopy frame side) and cockpit frame may cause witness marks or cosmetic damage to the cockpit frame. This Technical Note sets out a procedure to modify the cockpit frame to prevent possible interference.

1. Scallop the sharp edges of the damaged spot to a smooth radius of 3mm. The radius around the damaged area must be 2mm larger than the radius of the damaged area. Grind the entire thickness of the side frame away, as illustrated by the hatched-out area on the picture below.
