# Technical Note TN.JS-017 v3.0

# 05 May 2014

Check correct operation of 21m tips water system.

Water system torsion tube longitudinal play repair procedure.

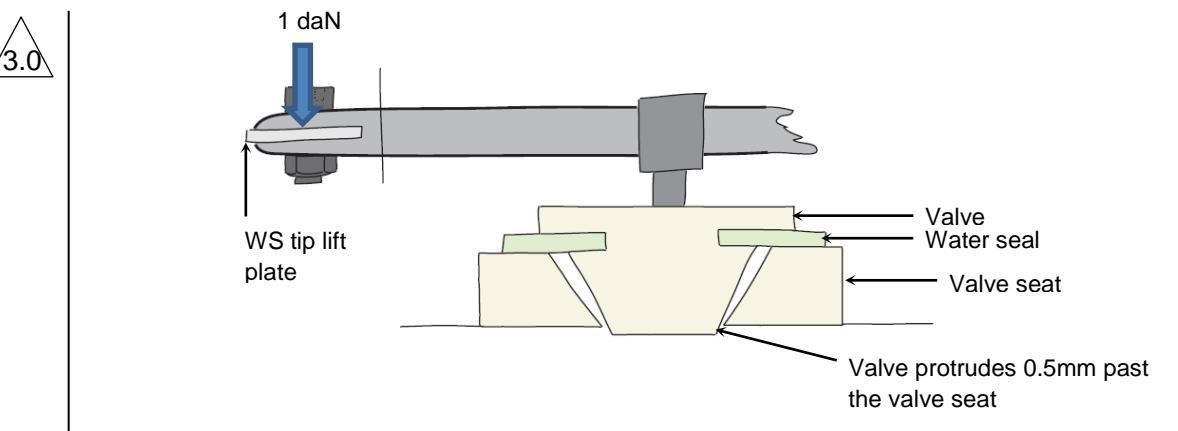
Figure 5: Protruding of valve body.

- 3. Position the 21m upside down on a suitable cushioned trestle.
- 4. Check that the 21m tip dump valves close fully.
- Apply a load (approximately 1 daN) on the WS TIP LIFT PLATE 21m. Check that the bottom of the TIP VALVE BODY 21M protrudes pass the TIP VALVE SEAT 21m by approximately 0.5mm when the load is applied. (Refer to Figure 5)

#### 6. If it does not protrude sufficiently:

- a. Remove the TIP VALVE RUBBER SEAL and clean it from any debris or dirt.
- b. Clean inner contact area of TIP VALVE SEAT 21m with your finger, as illustrated in Figure 6. Any built-up of dirt on the valve seat may prevent the valve from closing fully. A cloth can be used if more severe abrasion than rubbing is required.

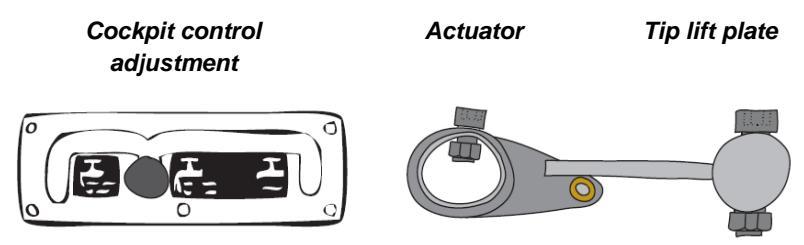
#### Figure 8: Clearance of Actuator

No clearance between the actuator and the lift plate

Between 0.1 mm and 1 mm clearance between the actuator and the lift plate

- a. Remove the TIP LIFT PLATE 21M.
- b. Change the bend angle on the TIP LIFT PLATE 21M to adjust the clearance. (Figure 8)
- c. Re-install the TIP LIFT PLATE 21M and measure the clearance. Re-adjust if required.

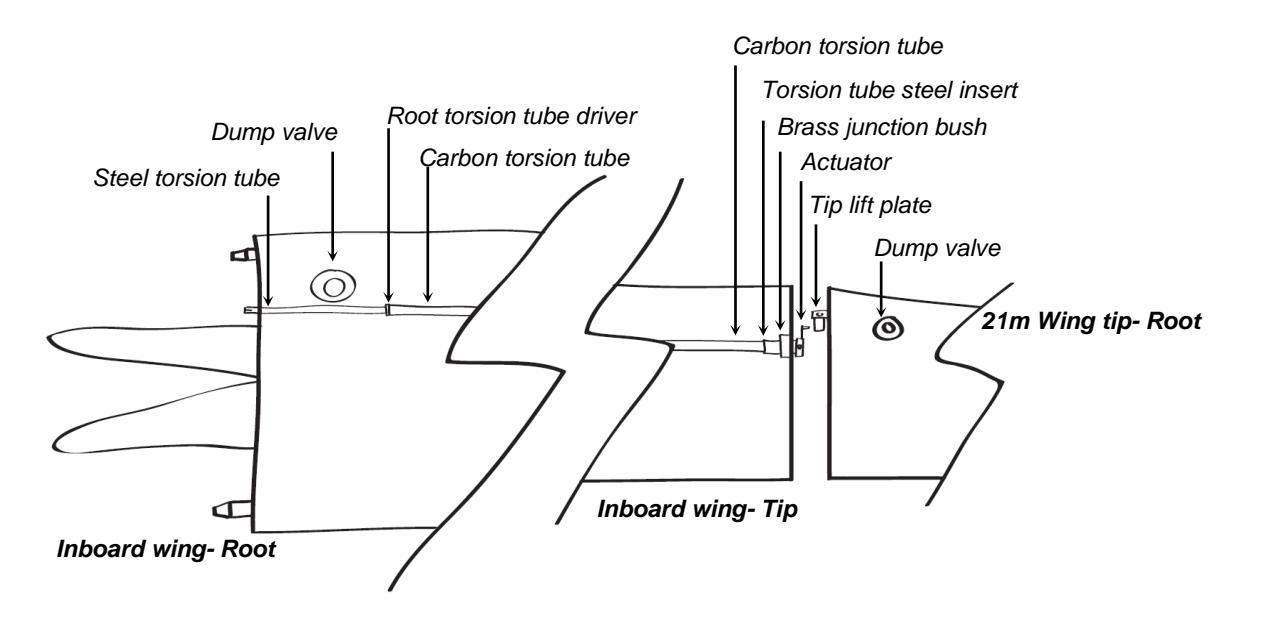
Figure 10: Descriptions of Wing & 21m tip water system

The longitudinal play in the carbon water system torsion tube may lead to malfunctioning of the 21m wing tip dump valve if not set-up correctly.

The maximum allowable longitudinal play for the torsion tube is 4mm. If the play exceeds this value it may cause the water system to mal-function in one of the following ways:

- The torsion tube to disengage at the inner wing root torsion tube driver, causing the tip water system to mal-function. (Refer to Figure 10 and Figure 11.)
- Insufficient contact length between the actuator cam and the tip driver lever at the wing-tip junction, causing the tip water system to mal-function. (Refer to Figure 10 and Figure 11.)
- Interference between the ACTUATOR and the TIP LIFT PLATE when the ACTUATOR is in its maximum longitudinal position. (Refer to Figure 10 and Figure 11.)

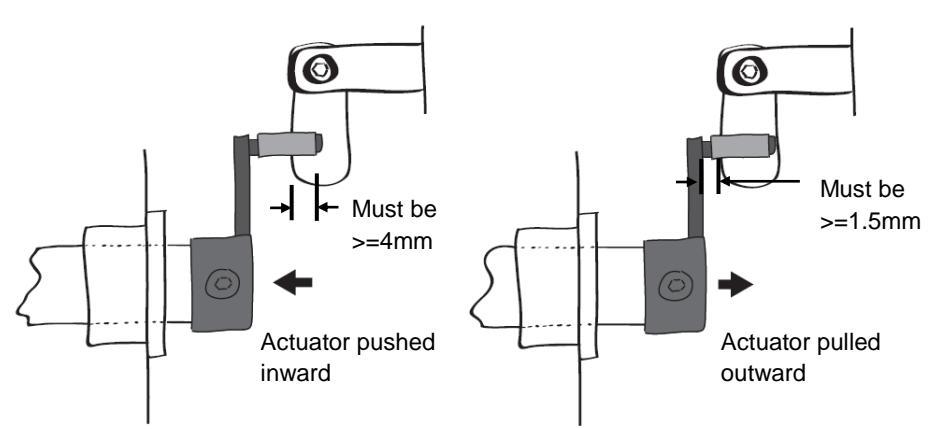
Figure 12: Maximum and minimum clearance of the Actuator

- The tip is not appropriately rigged or
- the actuator does not come into contact with the driver lever.(If this is the case the manufacturer should be contacted for further technical support.)
- a. Position the cockpit dump valve lever in the backward position. (All valves closed)
- b. De-rig the 21m wing tip.
- c. The ACTUATOR CAM should have made an imprint on the modelling clay indicating the contact length.
- d. Contact length must be at least 4mm. If the contact length is less than 4mm, contact the manufacturer for further technical support.
- e. Repeat the above mentioned procedure, but with the actuator pulled outward as far as possible.
- f. A minimum clearance of 1.5mm is allowable between the ACTUATOR and the TIP LIFT PLATE. (Refer to Figure 12). If the clearance between the two mechanisms is smaller than 1.5mm, contact the manufacturer for further technical support.

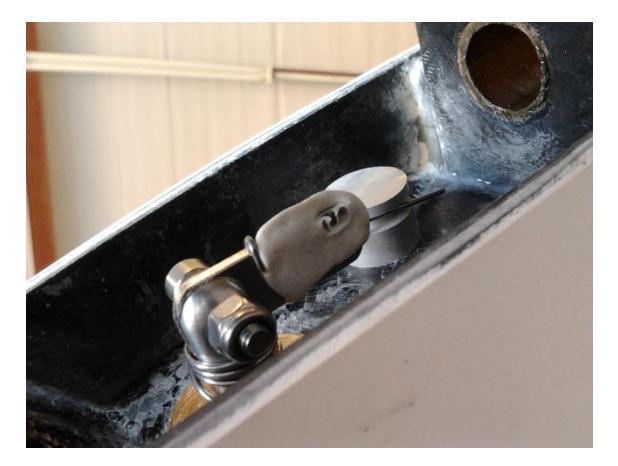
Figure 13

Wing-tip-side-water-system-driverlever with modelling clay. Insufficient contact length (<4mm)

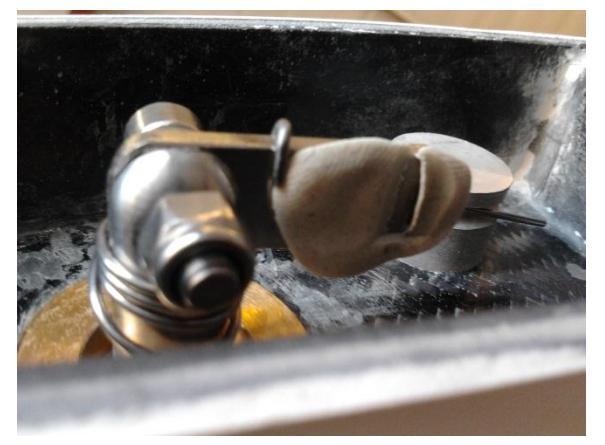
Wing tip side water system driver lever with modelling clay. Sufficient contact length (>4mm) Figure 14

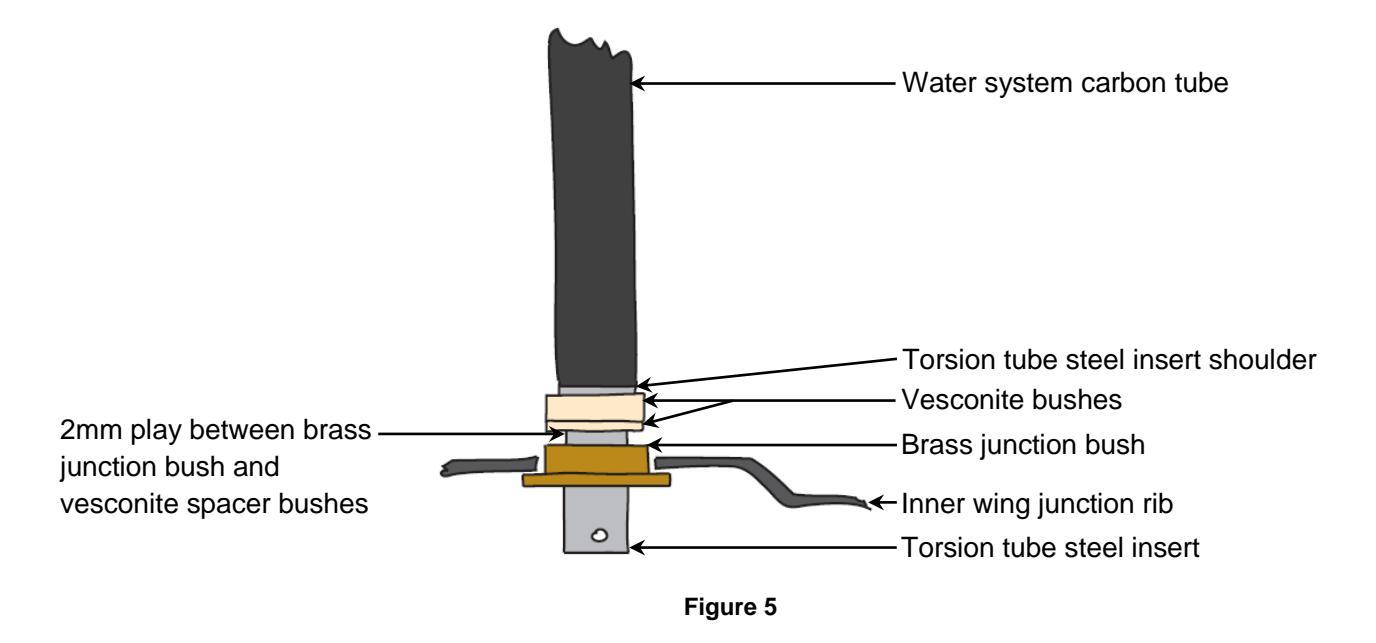
The carbon torsion tube in the inboard wing might disengage at the root torsion tube driver if the longitudinal play on the water system is more than 4mm (Play must be between 2 and 4mm).

Insert one or a combination of the Vesconite bushes (total bush length = X - 2mm) over the torsion tube, between the junction bush and the torsion tube shoulder.

- 6. Push the brass junction bush back into position and check the total longitudinal play on the system. (It must be in the order of 2mm)
- 7. Repeat the two preceding steps until the correct amount of play is achieved.
- 8. Re-bond the junction bush into its position using Spabond.
- 9. Install a new water seal.
- 10. Fasten the actuator to the torsion tube.
- 11. Repeat the entire inspection as described in Technical Note 17. (TN.JS-017)
