# Technical Note TN.JS-017 v3.0

# 05 May 2014

Check correct operation of 21m tips water system.

Water system torsion tube longitudinal play repair procedure.

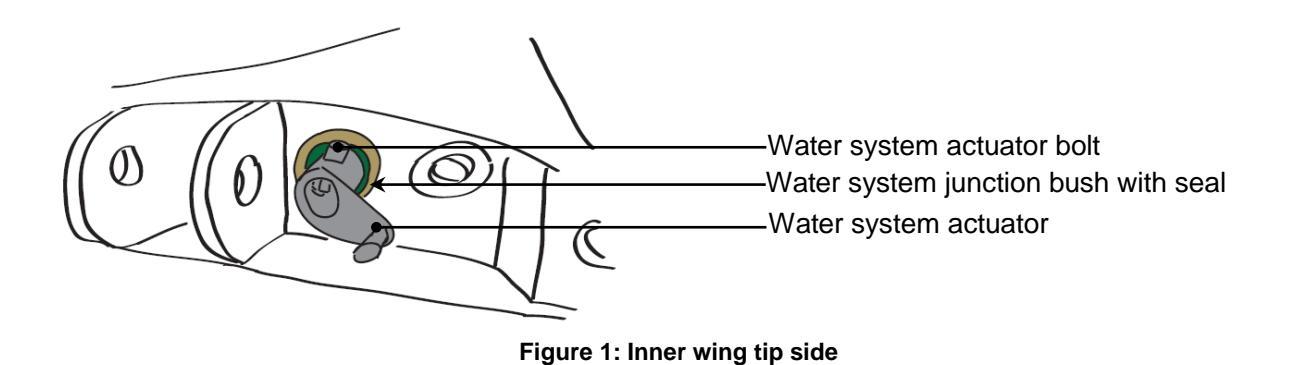
Inserting spacer bushes between the junction bush and the torsion tube steel insert shoulder the amount of longitudinal play will be reduced and the whole system will move closer to root-Ensuring the carbon torsion tube cannot disengage at the root torsion tube driver.

- 1. Measure the amount of longitudinal play on the water system by pushing and pulling on the actuator and denote it as "X".
- 2. Remove water system actuator by removing actuator bolt.
- 3. Remove water system junction seal. Take care not to damage the brass junction bush while removing the seal.

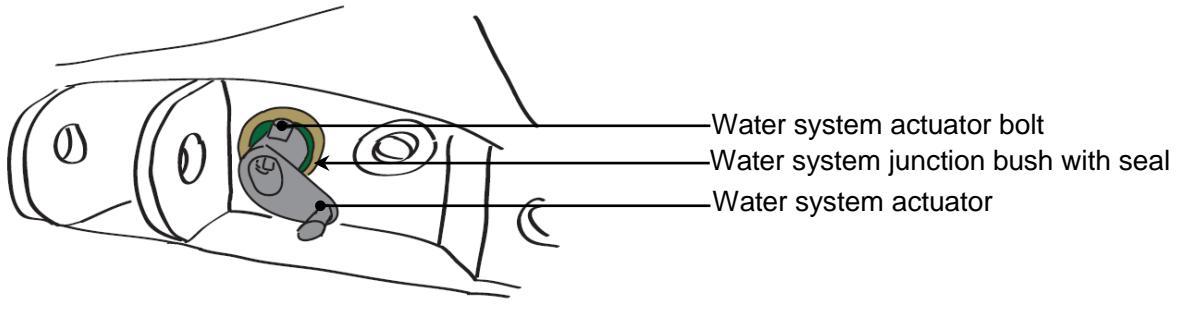
Figure 6: Inner wing tip side

When the carbon torsion tube inside the wing is lengthened via a repair the problem can be resolved.

- 1. Measure the amount of longitudinal play on the water system by pushing and pulling on the actuator and denote it as "X".
- 2. Remove water system actuator by removing actuator bolt.
- 3. Remove water system junction seal. Take care not to damage the brass junction bush while removing the seal.
