# Service Bulletin SB.JS-013

Extension of Airbrake Blade 3

Document name:	Document number:	Rev:	Document issue date:	
Possible fouling of airbrake blade 3	SB.JS-013	2.0	06 June 2012	Page 1 of 5

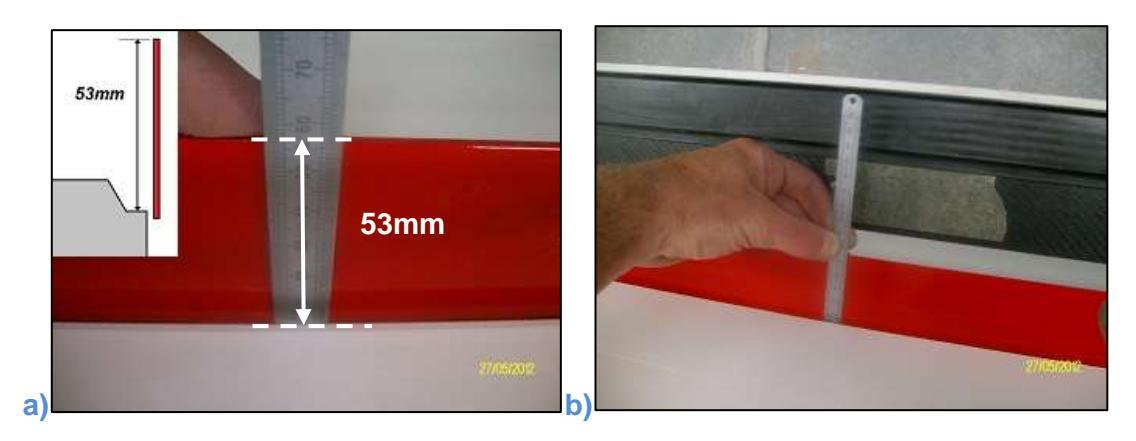
Figure 1: Measuring of airbrake cap recess

The measurement should be taken, in the middle of the airbrake, from the surface of the airbrake cap recess to the top edge of airbrake blade 3, as illustrated in Figure 1a&b. If this measurement is more than 53mm, Part 2 of this Service Bulletin is applicable.

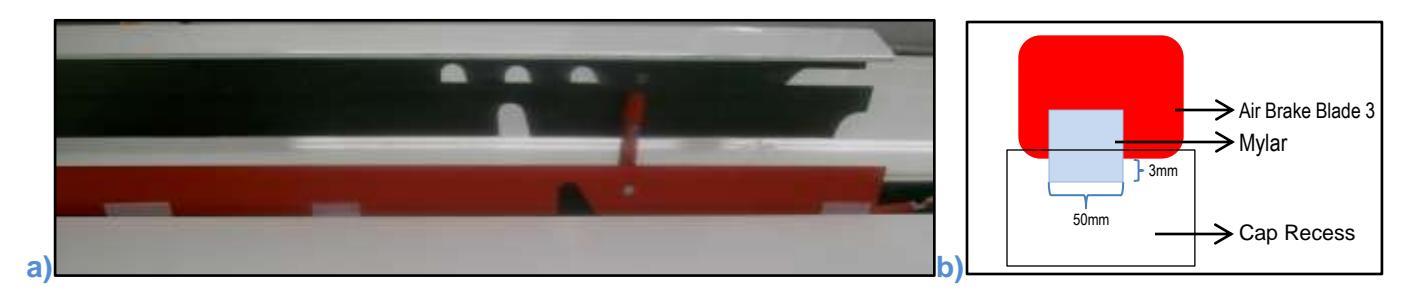
Figure 2: Interim solution, Mylar attached to airbrake blade 3.

Apply three or four, 50mm width Mylar strips onto airbrake blade 3. Start at the middle of the blade and continue to the tip side, adding the rest, at various lengths, as illustrated in Figure 2a. Each strip should extend roughly 3mm below the edge of the blade, as illustrated in Figure 2b.

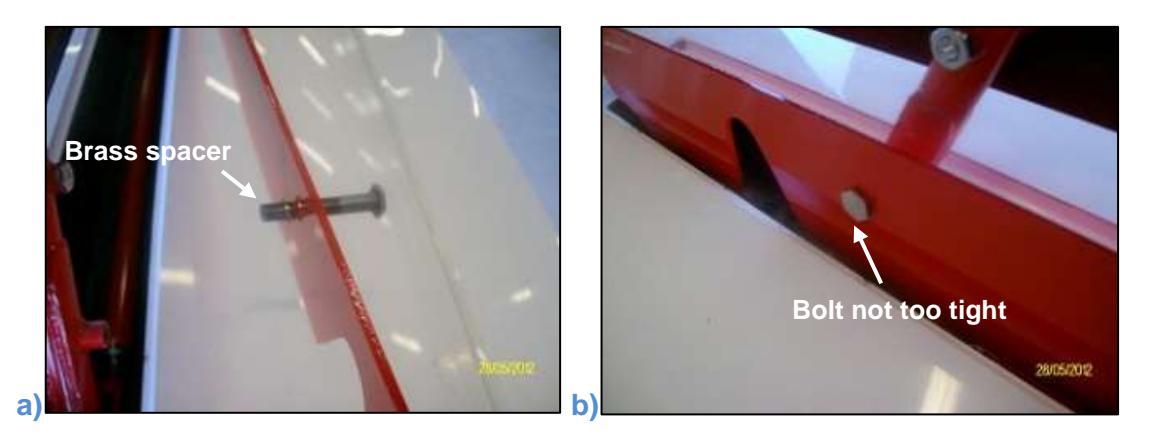
Figure 3: Brass spacer & bolt tightening

- 1. Remove airbrake blade 3 by releasing the locknuts from the peened M6H12/37 bolts and removing these bolts. Take note where each brass spacer, as illustrated in Figure 2a, is installed as they have to be reinstalled in the same position.
- 2. Install the new airbrake blade using the supplied M6H12/37 bolts and the original brass spacers.

- 3. Lock the bolts in Figure 2b, while allowing sufficient free movement of the blade.
- 4. Use the supplied flat M6 self-locking nuts to lock the bolts to the airbrake lifters as illustrated in Figure 3.

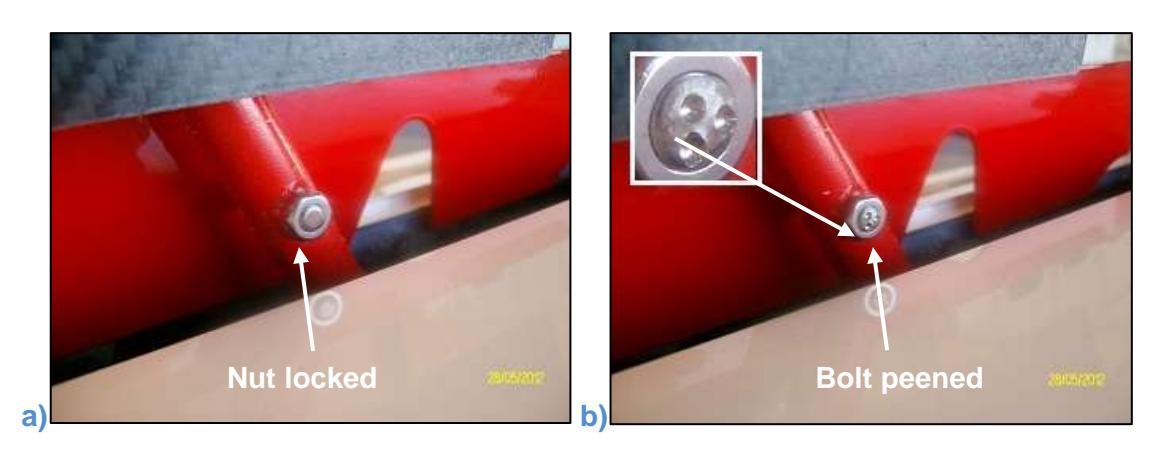
Figure 4: Bolt peening

- 5. Trim the ends of the bolts if they protrude by more than 1½ threads.
- 6. Test operation.
- 7. Protect the surface of the wing skin. Peen the end of the bolt with a centre punch and a hammer, with the bolt pressing against a 5kg counterweight at the back, as illustrated in Figure 4.
